Manhole Inspection Summary

Manhole # S21I__017MH

Insp Date: **9/24/07 12:32 PM**

Location Address: **1735 HOLLINS ST**

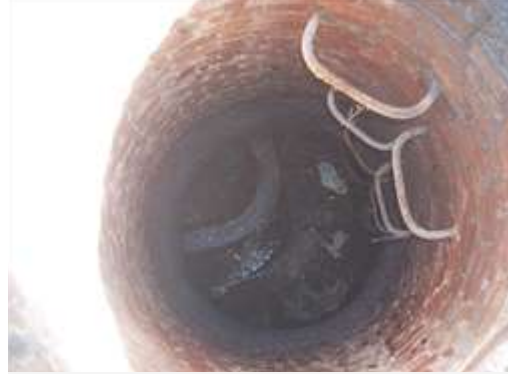
Top View

DEBRIS ON BENCH AND IN CHANNEL

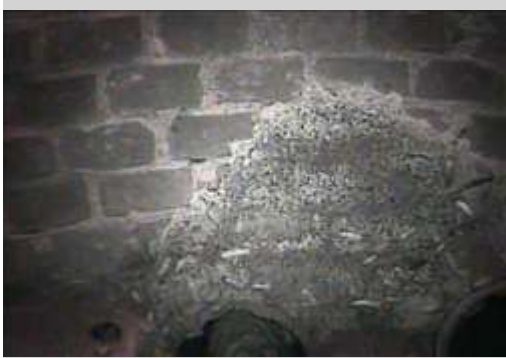
Defect 5

Comments **SOME WHITE MATERIAL ON BARREL BETWEEN I8 AND I9**

WHITE MATERIAL ON BARREL WALL

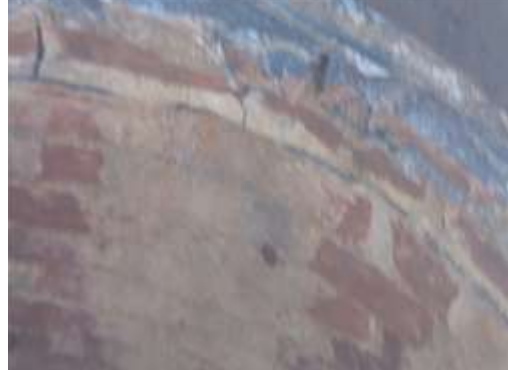
Defect 4

Infiltration: ☐ None ☐ Joint ☐ Cracks ☐ Mortar ☐ Roots ☒ **Wall**

INFILTRATION OF CORBEL

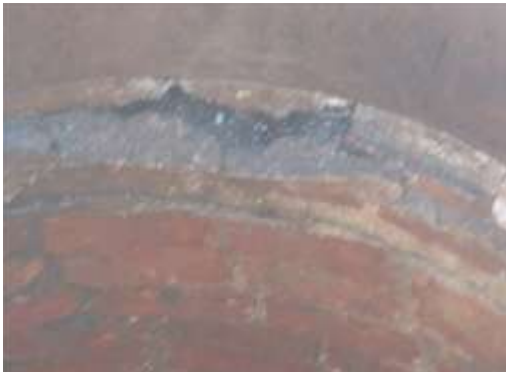
Defect 3

Condition: ☐ Sound ☐ Cracked ☐ Root Intrusion ☐ Loose Brick ☒ **Deteriorated**

DETERIORATION OF CHIMNEY

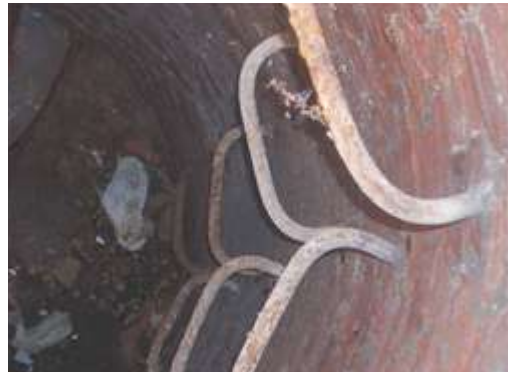
Defect 2

CORRODED STEPS

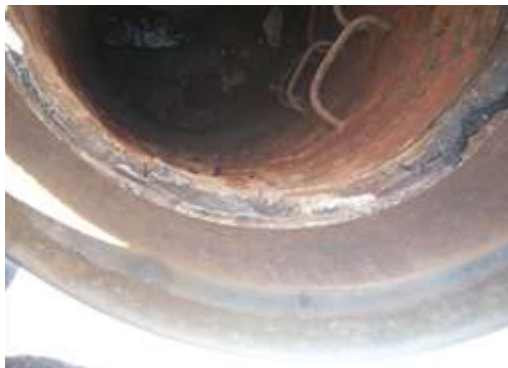
Defect 1

Offset: **1** (in.)

FRAME OFFSET

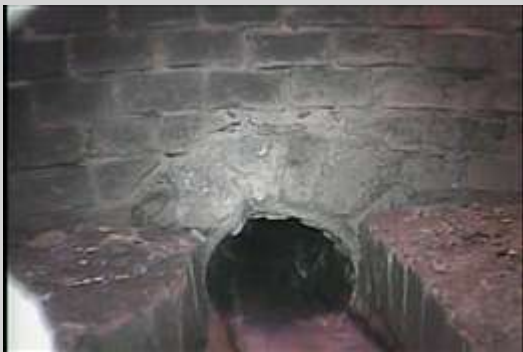
12 O'Clock Outflow

Pipe Height: **8.4** (in.) Rod and Bar (Angled)
Pipe Material: **Clay** ☐ Pipe Lined
Invert Depth: **11.35** (ft.) Flow Characteristics: **Slow**
Deposits: ☒ None ☐ Mud ☐ Sludge ☐ Debris ☐ Grease
Silt Depth: (in.) Deposits Extent:
Infiltration: **None** Pipe Seal Cond: **Sound**

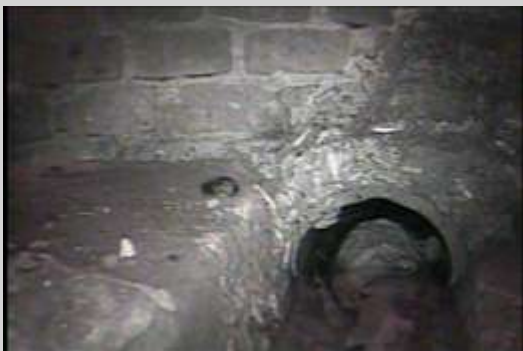
8 O'Clock Inflow

Pipe Height: **8.4** (in.) Rod and Bar (Angled)
Pipe Material: **Clay** ☐ Pipe Lined
Invert Depth: **11.19** (ft.) Flow Characteristics: **Slow**
Deposits: ☐ None ☐ Mud ☒ **Sludge** ☐ Debris ☐ Grease
Silt Depth: **4** (in.) Deposits Extent: **Medium**
Infiltration: **None** Pipe Seal Cond: **Sound**

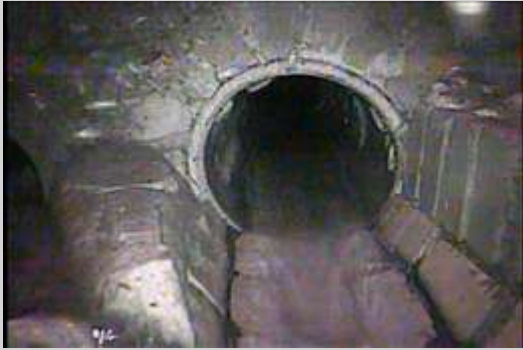
9 O'Clock Inflow

Invert Depth: **11.28** (ft.) Flow Characteristics: **Slow**

Deposits: ☒ None ☐ Mud ☐ Sludge ☐ Debris ☐ Grease
